**Inspection Location:**

**Inspection Date:**

November 14, 2009  
6:30 p.m.

**Report Date:**

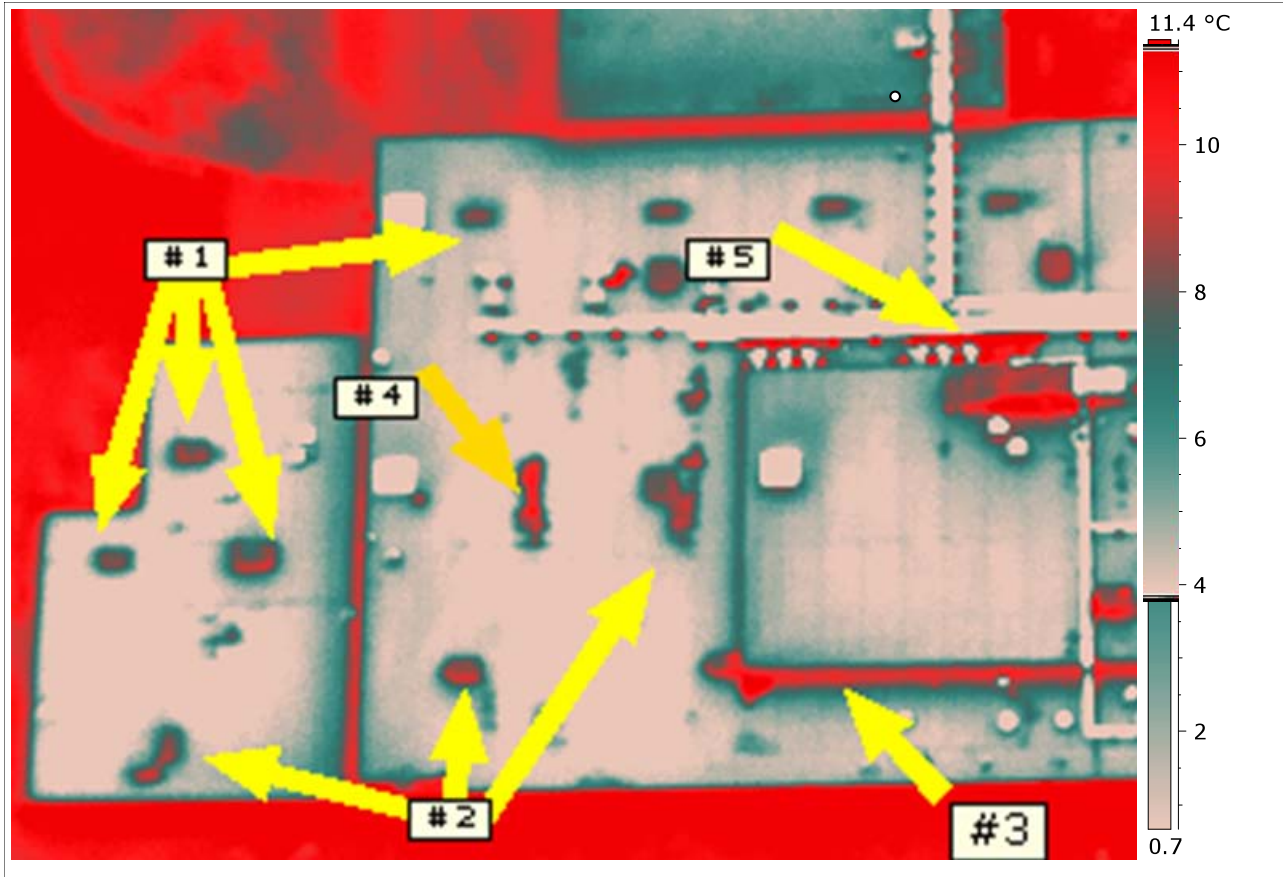
**Section A ( Enlarged 2X):**

Area #1 - Partial areas may be reflections off units. Field Verification needed to determine.

Area #2- Partial areas may be reflections off units. Irregular migrating patterns indicate areas of concern.

Area #3 - Partial areas may be reflections off Masonry wall. Corner migrating pattern may be area of concern. Field Verification needed to determine.

Area #4 - Area of extreme concern.

Area #5 - Partial areas may be reflection off duct work. Migrating red patterns may be from upper or lower roof areas which indicate areas of concern. Field verification needed to determine.

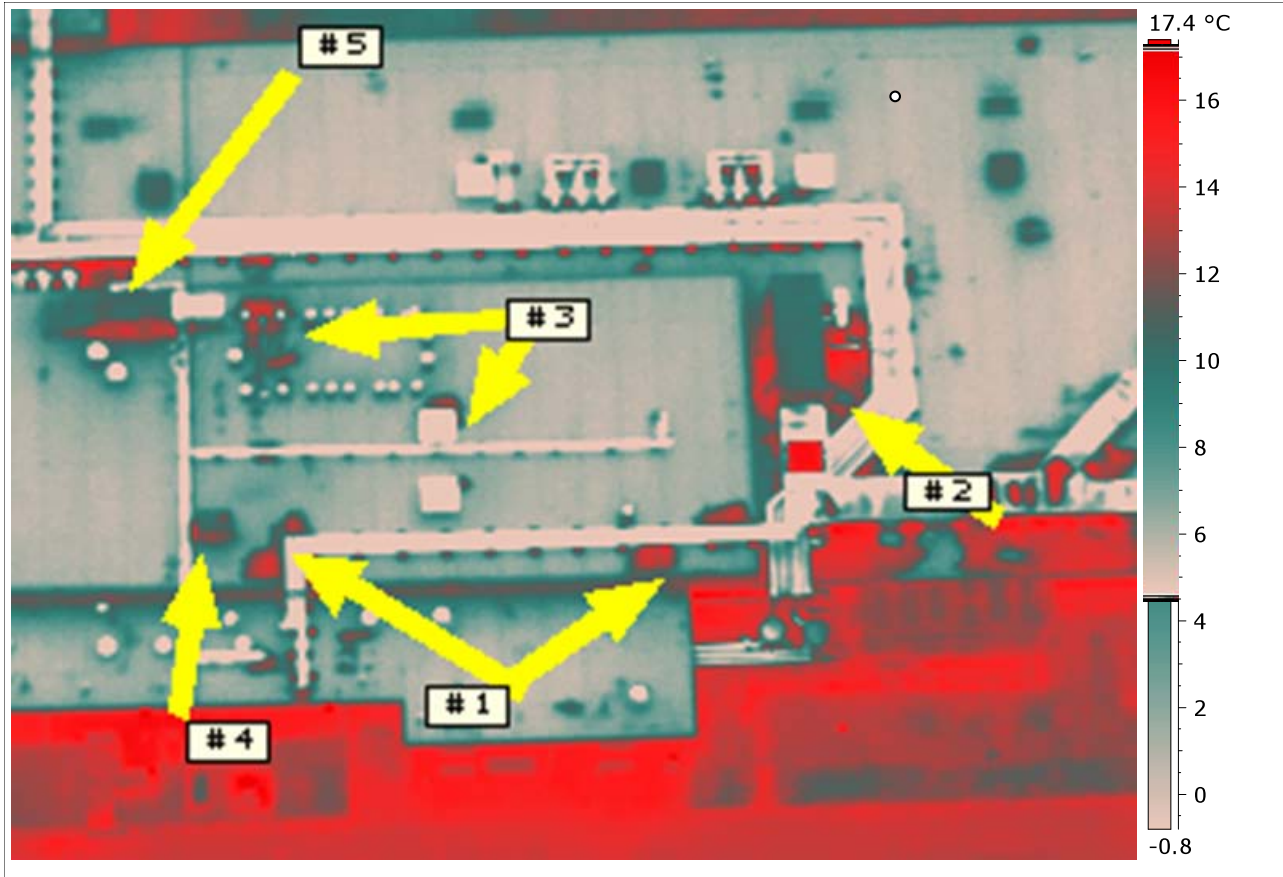
**Section B (enlarged 2X):**

Area #1- Partial areas may be reflections off masonry wall. Irregular migrating patterns may be area of concern. Field Verification needed to determine.

Area #2- Partial areas may be reflection off duct work. Migrating red patterns indicate areas of extreme concern. Field verification needed to determine.

Areas #3 & #4- Partial areas may be reflection off units. Migrating red patterns indicate areas of extreme concern. Field verification needed to determine.

Area #5- Partial areas may be reflection off duct work. Migrating red patterns indicate areas of extreme concern. Field verification needed to determine.

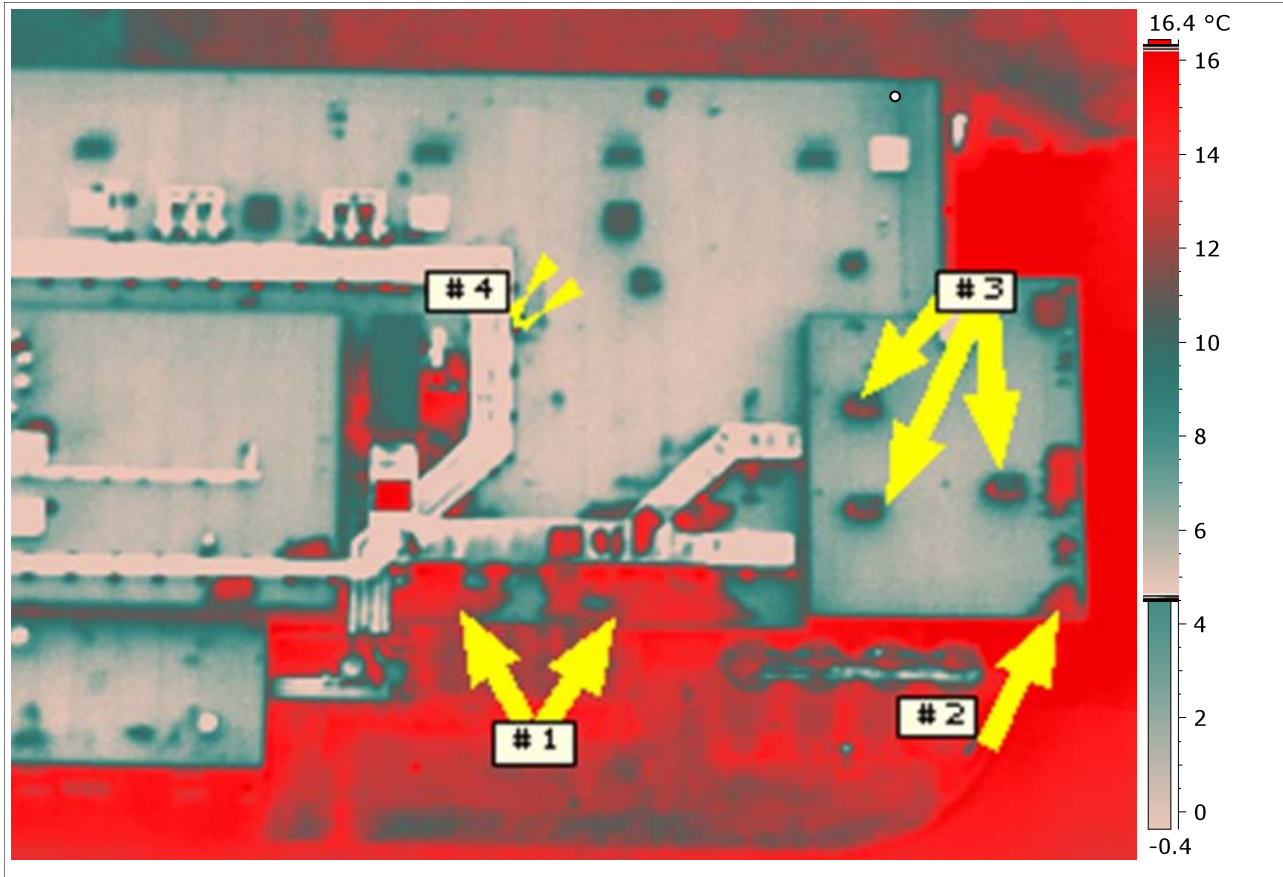
**Section C ( Enlarged 2X):**

Area #1- Partial areas may be reflection off duct work. Migrating red patterns indicate areas of extreme concern. Field verification needed to determine.

Area #2 – Areas of concern due to the irregularity patterns along edge of roof.

Area # 3- Partial areas may be reflection off units. Migrating red patterns indicate areas of extreme concern. Field verification needed to determine.

Area #4- Also shown in section B; Partial areas may be reflections off units. Migrating patterns indicate areas of extreme concern. Field verification needed to determine.
